Corrosion Camera

Description: A portable imaging system utilizing infrared light to evaluate pipeline corrosion.

Status: Feasibility study completed.

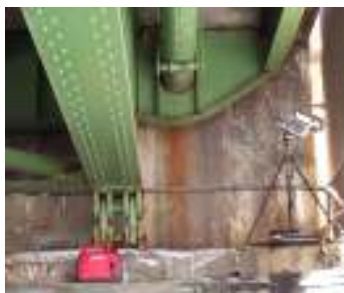
Lab Scale Prototype under a Bridge Crossing

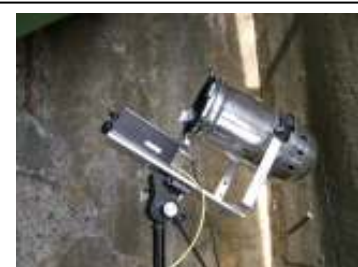
Lab Scale Prototype

Active thermography was found to be successful in identifying corrosion under coatings. A concentrated light source was used to project heat onto a distant pipe (30' to 50' away). It was proven that areas under a coating which trap corrosion products have less thermal conductivity than adjacent areas with no corrosion products or coating disbond. Thermal imaging illustrated the areas having greater temperatures. These higher temperatures are due to differences in heat transfer properties at locations which have corrosion or coating disbonds.

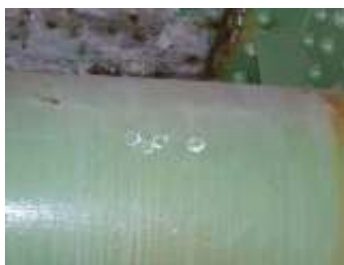
Areas of Predicted Corrosion

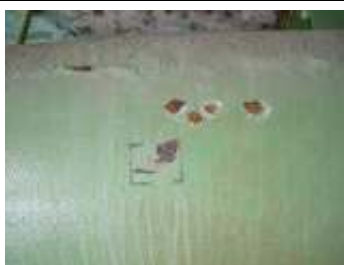
Minor Corrosion Revealed
