Service Tee Renewal

Description: Project will develop a method to trenchlessly seal a service tee by gaining internal access to the tee and applying a sealant to existing or potential leaks.
Status: Laboratory testing of sealants proceeding

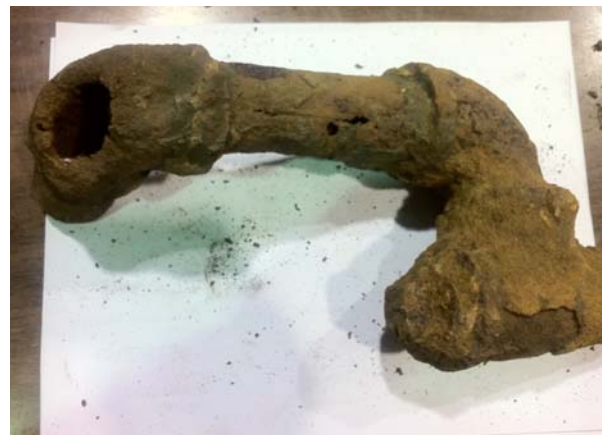
Figure 1: Decommissioned Service Tee

TTC is developing a sealant and delivery system through laboratory testing using decommissioned service tees (Figure 1). A variety of sealants are being tested in combination with stents to seal larger leaks. A mechanical delivery system is being developed to provide complete service tee rehabilitation via access at the customer's meter set (Figure 2).

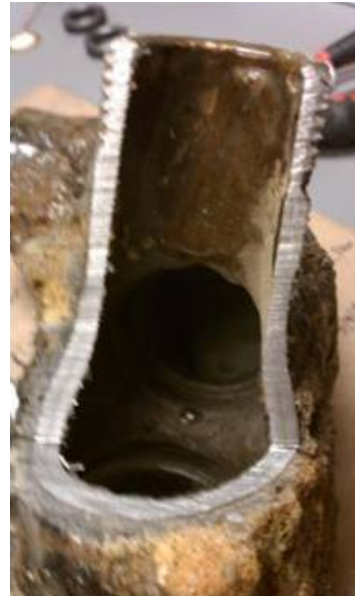
Funding companies have supplied the TTC laboratory with decommissioned service tees. TTC tested multiple sealants for application, adhesion and sealing performance (Figure 3). Laboratory test results of the sealants are under funder review. TTC has recommended moving forward with an adhesive sealant and stent combination. Mechanical delivery methods of the sealant and stent are in the conceptual phase and are being prepared for funder consideration.

Figure 3: Cutaway View of a Test Service Tee After Adhesive Application
