# Technology Brief

## Butt Fusion Repair Sleeve (BFRS) for PE Pipe

**Description:** An electrofusion fitting to reinforce defective PE pipe joints  
**Status:** The BFRS fitting is commercially available in a 4" size.  
The 6" BFRS is under development.

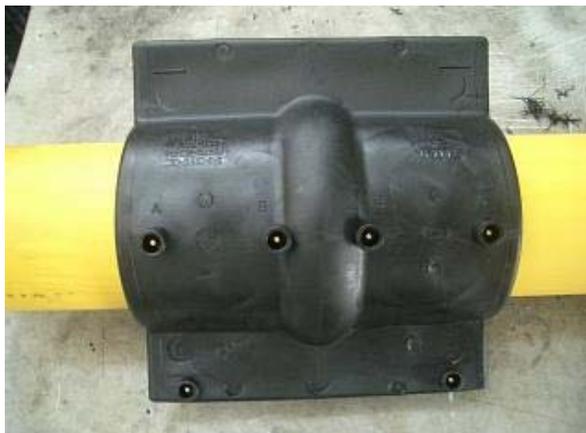
Figure 1: BFRS Installed on PE80 Pipe

NYSEARCH is designing, developing and testing a repair fitting for PE butt fusion joints with a manufacturer, NUPI-GECO Systems of Italy. The split-type repair sleeve, also known as BFRS (Butt Fusion Repair Sleeve), provides a 360° electrofusion repair around the entire circumference of the pipe. Although statistics show that butt fusion joint failures occur infrequently in the field, questionable joints are encountered during routine work that do not meet existing visual examination guidelines. The only repair that can be made, other than using mechanical fittings, is to physically remove the butt fusion joint(s) in question. To accomplish this, a pipeline shutdown is typically required (flow interruption) to remove the joint. This is a costly and time consuming process that requires additional excavations, specialized equipment and, at times, disruption of gas service to customers. The BFRS fittings provide a permanent lower-cost repair option and improve overall safety to gas company operators and the general public (Figure 1).

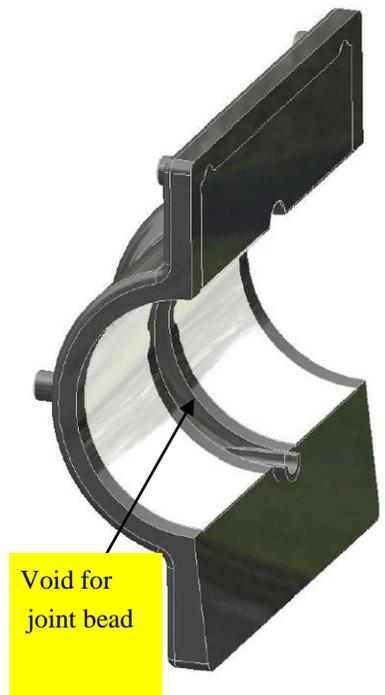
The BFRS fitting allows for a joint repair to be made without interrupting gas service. The fitting is comprised of PE100 material that can be electrofused to all PE pipe materials. The special design has an internal channel to accommodate the external bead of the butt fusion joint. This eliminates the need to physically remove the bead during the repair process (Figure 2).

Figure 2: BFRS Void Area

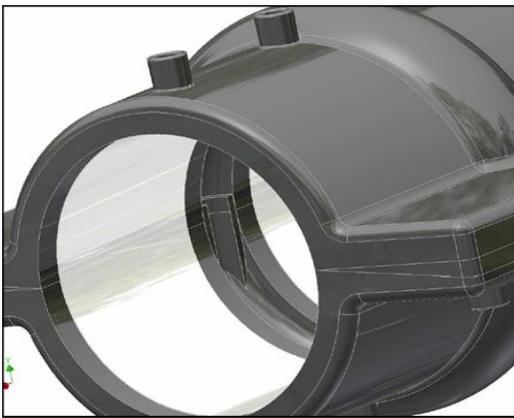
The objective of this effort was to design, develop and test a PE electrofusion fitting to repair poorly fused, suspect or weak butt fusion joints. Based on the funders needs, it was decided that the initial pipe size to be developed would be for 4" PE pipe. The split-sleeve fitting is designed to fully encapsulate the fusion bead and PE pipe, thereby making a full encirclement repair. A specially designed cavity or void in the middle of the fitting is placed over the bead area (Figure 3). Therefore, the joint bead does not need to be disturbed or removed to apply the BFRS fitting, which is an important safety feature for gas operators. In addition, during the installation process the fitting does not require the pipe ends to be retained with clamps/anchors; unlike the typical installation for standard electrofusion couplings.

Figure 3: Graphic — BFRS

The BFRS installation requires the pipe surface to be cleaned using a pipe scraper tool in accordance with standard electrofusion procedures. The fitting halves are positioned over the joint and its flanges are clamped together to secure the fitting to the pipe prior to electrofusion. The fitting is fused in three steps: 1) top-half of circumference, 2) bottom-half of circumference and 3) both flange ends. The entire electrofusion process is a little over (5) minutes, followed by a (30) minute cooling period prior to removing the clamps. The BFRS fitting is equipped with a universal code label and uses standard electrofusion equipment.

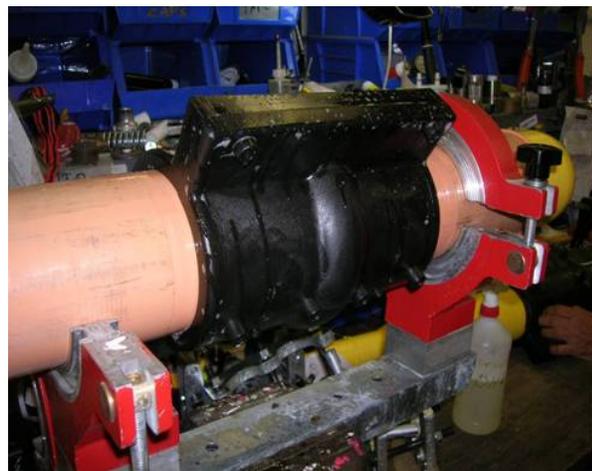
Figure 4: BFRS Under Pressure Test in Lab

GECO and NYSEARCH have completed all tests required for the fitting and it meets ASTM and ISO requirements. The BFRS fitting is commercially available in 4" sizes and is being distributed by NUPI Americas and Mulcare in the Northeast. A 6" BFRS fitting is being developed by GECO and is funded by NYSEARCH member companies (Figure 4).
