# New Repair Sleeve Coming For Gouges and Suspect Joints In PE Pipe

By **Marco Genoni, GECO System S.p.A.**, Lonate Pozzolo, Italy, and **NUPI Americas**, Houston; **Angelo Fabiano, NYSEARCH-Northeast Gas Association**, New York, NY; and **Brandon Wheeler, NUPI Americas**, Houston

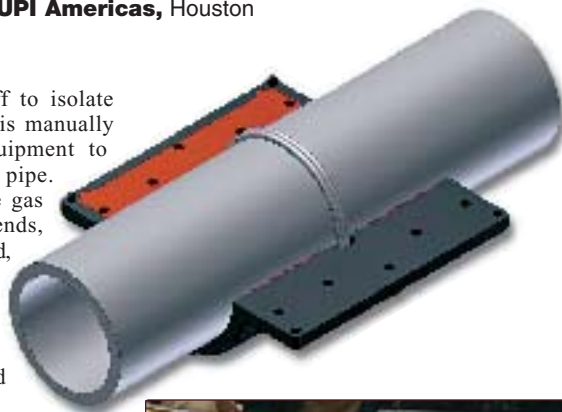
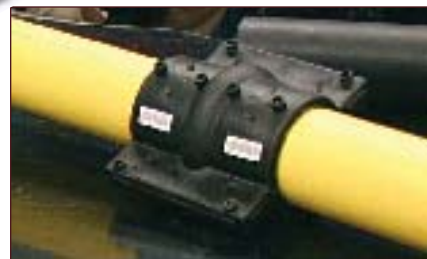
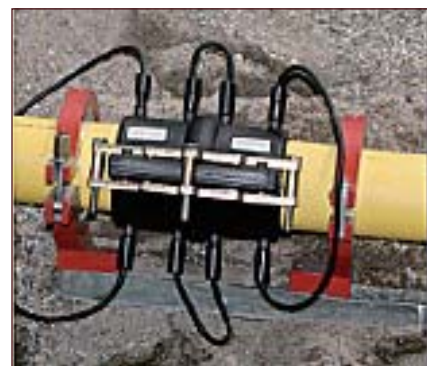
The patch is 8.66 inches long. It consists of two separate, non-identical, shells that are bolted together over the pipe at the point of the butt fusion. Indentations in the center of the inside surfaces of the two sleeves are designed to accommodate the butt fusion bead. Therefore, the fusion bead does not have to be disturbed.

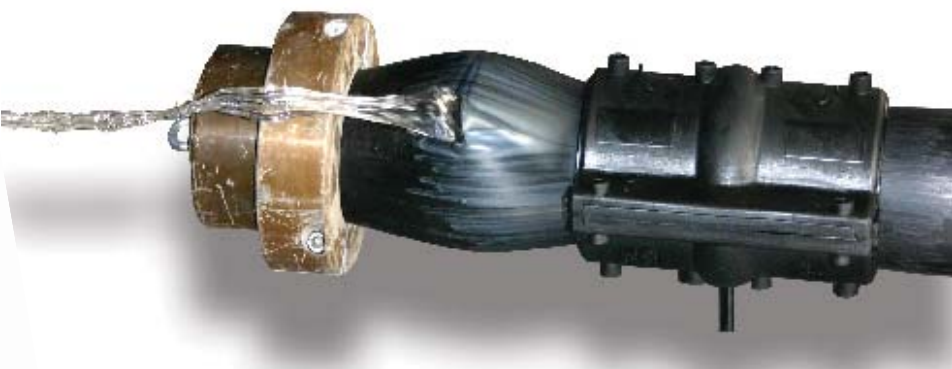
ERP During Hydrostatic Burst Test.

The ERP fitting meets all ASTM requirements specified in “F1055-98: Electrofusion Type Polyethylene Fittings For Outside Diameter Controlled Polyethylene Pipe And Tubing.” Pressure testing has confirmed that the fitting can be installed successfully on live PE pipe with internal pressures up to 124 psig. Since the fitting is reinforced around the entire circumference, it can be installed over damages/gouges up to five inches in length on the pipe surface.

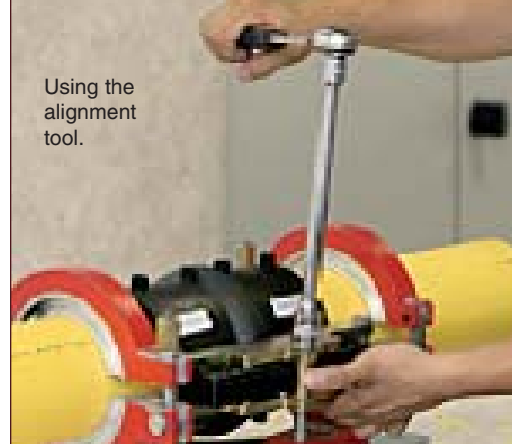
Using the alignment tool.

or gouges require multiple VLRS fittings. Both the single and multiple applications need a special alignment tool. Additionally, the special VLRS design allows for the fitting-ends to overlap each other, thereby creating one continuous electrofusion between the pipe and each VLRS fitting.

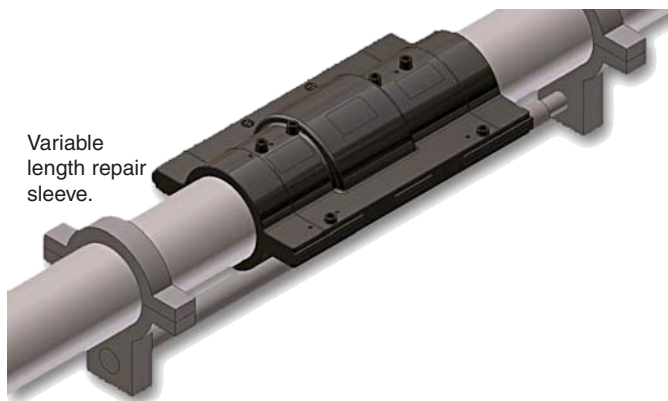
Variable length repair sleeve.

The VLRS is expected to be available for introduction into the U.S. market in 2008. The VLRS is a repair sleeve for damaged PE pipe with the ability to accommodate gouges of any length. It consists of fittings that can be arranged consecutively so that — when electrofused — they form one continuous sleeve that re-establishes the integrity of the damaged pipe.

The single sleeve is approximately 16 inches long and can repair a gouge length of up to 10 inches long. Longer damages
