Multi-Technology Validation Testing for Cased Pipe Applications

Description: A program to compare and evaluate the performance of new and existing technologies for inspection of live cased pipe.

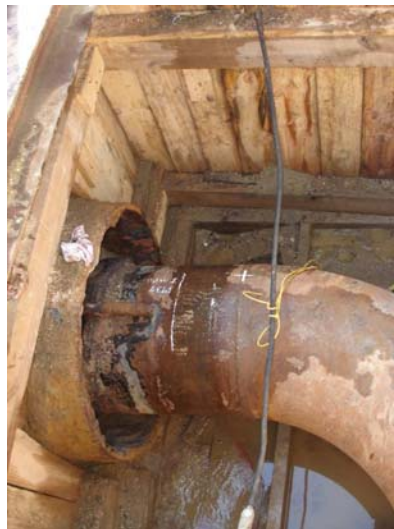
30" Carrier within a 48" Cast Iron Casing

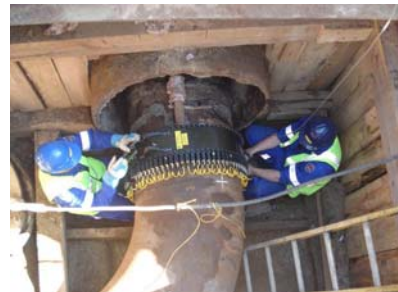
Guided Wave Transducer Belt in Place

Five guided wave inspection contractors participated in the 2007 portion of the test program. Their equipment consisted of both Guided Ultrasonics Limited (GUL) and Teletest™ devices.

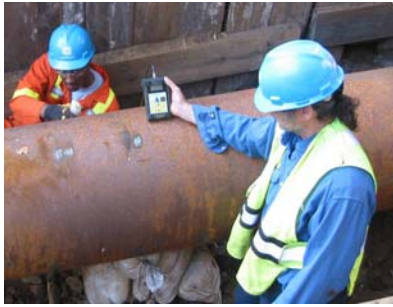
Ultrasonic Thickness Gage Verification

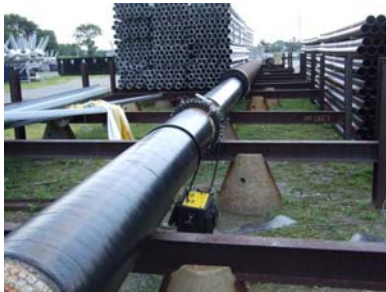
One of the cased test sections was an above-ground field mockup which contains multiple known machined defects.

ConEdison Astoria Yard Field Mockup
