## Butt Fusion Repair Sleeve for PE Pipe

**Description:** Butt Fusion Repair Sleeve (BFRS) - an electrofusion fitting designed to reinforce defective PE pipe joints.

**Status:** BFRS is manufactured by NUPI-Americas/GECO Systems. Fittings are commercially available in 4" pipe size.

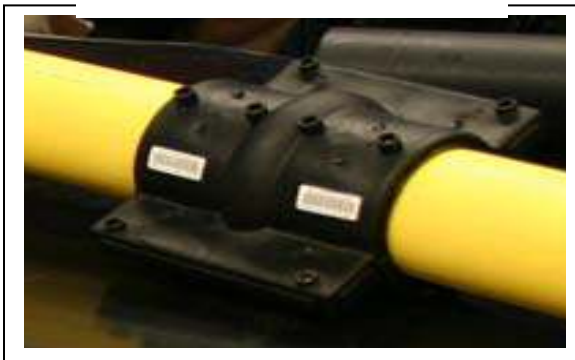
BRFS After Electrofusion

The BRFS is molded using PE 100 materials and is initially bolted on to the pipe after the cleaning process. A specially designed cavity in the middle of the fitting is placed over the bead area. After installation, the BRFS is fused to the pipe using a universal electrofusion box and standard bar code application.

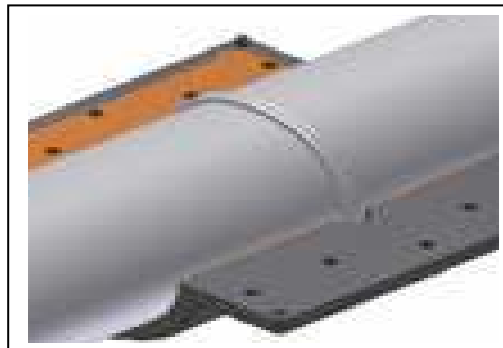
BFRS with void for fusion bead

The first fitting being developed is a split-sleeve for 4" PE pipe only. The fitting is specially designed to fully encapsulate the fusion bead and carrier pipe. This fitting requires the ends to be retained with clamps/anchors during the installation process, typical of any electrofusion couplings. The bead does not need to be disturbed or removed to apply the fitting. This is an important safety feature for gas utilities.

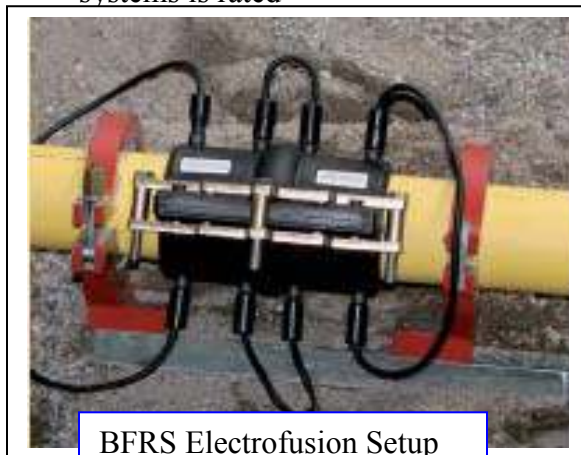
BFRS Electrofusion Setup
